REPORT NO: BT-AUV-18-001 MIAMI-DADE CERTIFICATION #17-1010.33

TESTING OF CONCENTRATED LOAD, PER FLORIDA BUILDING CODE 1618.4.6, STATIC WIND LOAD TAS 202-94(ASTM E330-02), LMI & SMI IMPACT TAS 201-94(ASTM E1996-14a), AND IMPACTS PER ANSI Z97.1 FOR "GARDA SP300 (PL1 300) & SP200 (PL1 200)"

Product Description of Units: Mock Up 1: GARDA SP300 (PL1 300)

Mock Up 2: GARDA SP200 (PL1 200)

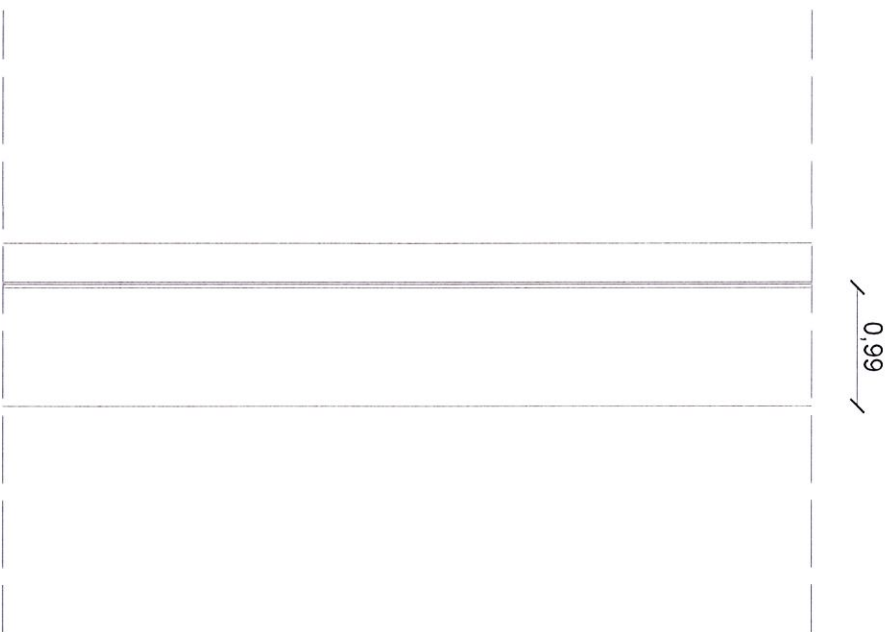
Lateral carter (KL) +
rubber gasket Rubber gasket beetwen
carter and glass 10/10 (GUB 2)
Extruded aluminum 6060
